Roose + Partners

Casualty Newsletter 93

7th January 2015

Hoegh Osaka

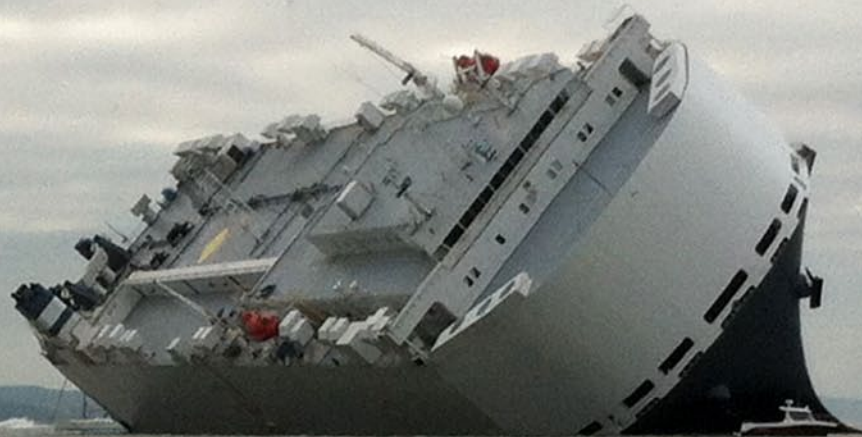
The grounding of the *Hoegh Osaka* has been well reported this week with graphic pictures of the vessel listing at a reported 52° on a sandbank off the Isle of Wight after encountering stability problems on her departure from Southampton. Our very own Nick

The vessel, which was heading for Bremerhaven in Germany, was under pilot control when owners Hoegh Autoliners advise she began listing

severely. To prevent a possible capsizing the Master and pilot chose to ground the vessel on Bramble's Bank. The crew of 24 and pilot were rescued by a coastguard helicopter and lifeboats although initially two officers and the pilot remained on board. Professional salvors, Svitzer have been appointed to provide salvage assistance to the carrier under an LOF Salvage contract, the first Lloyd's Open Form of 2015. A team from Svitzer has boarded the casualty and reported that for the most part the cargo remains well secured and may not have suffered as much damage as has been speculated. Some larger vehicles have moved and an excavator has shifted knocking a hole in the hull, which salvors have repaired. Some water ingress has been noted and this has prevented the salvors from attempting a refloating

today. An attempt may be taken tomorrow after dewatering. There is some concern about a deterioration in the weather and the effects of the tide on the sand support around the vessel. She is shifting under the influence of the tide and will have to be anchored down in the interim to prevent any movement.
